Form Number 1112

Town Lexington

Address 4 Reed Street

Historic Name Miller House

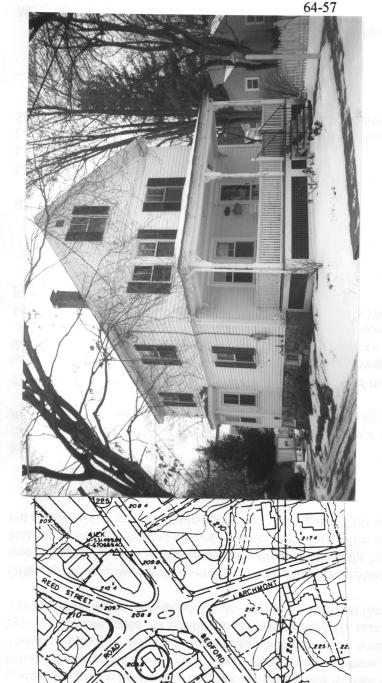
A simple and late example of the Queen Anne style, 4 Reed Street displays a common division of building materials with wood clapboards sheathing the first floor and wood shingles above, including the closed front gable decorated by cornice returns. The 2 1/2-story, front gabled, 2 x 2-bay house is set above a fieldstone foundation and is capped by an asphalt-shingled roof with a brick ridge chimney. The gablefront is spanned by a single-story, two-bay porch supported by turned posts with jigsawn brackets. The posts are set above a wooden deck with a latticed airspace and are spanned by simple stick balusters with balled newel posts. The sidehall entrance retains a glass-and-panel door. Adjacent is a pair of 2/1 windows. The second floor of the facade has an additional pair of 2/1 windows with an individual window above the entrance and lighting the front gable. In addition to the predominant 2/1 sash, there is a stained glass window on the second floor of the west elevation and a three-sided, single-story bay window at the rear of the east elevation.

Offset to the southwest is a two-story, c.1990, gablefront addition which is also sheathed in a combination of clapboards and wood shingles. A driveway extends along the east side of the house leading to a three-car garage at the rear. The c.1930 building is clapboarded and capped by a hip roof. Two of the original openings have been filled with overhead garage doors but a single set of hinged double-doors with upper glass lights over lower panels remains.
